SAFETY DEVICE FOR THE INVERTED SIPHONS
ON GATEWAY CANAL
WEBER BASIN PROJECT, UTAH

Hydraulic Laboratory Report No. Hyd-391

March 3, 1955

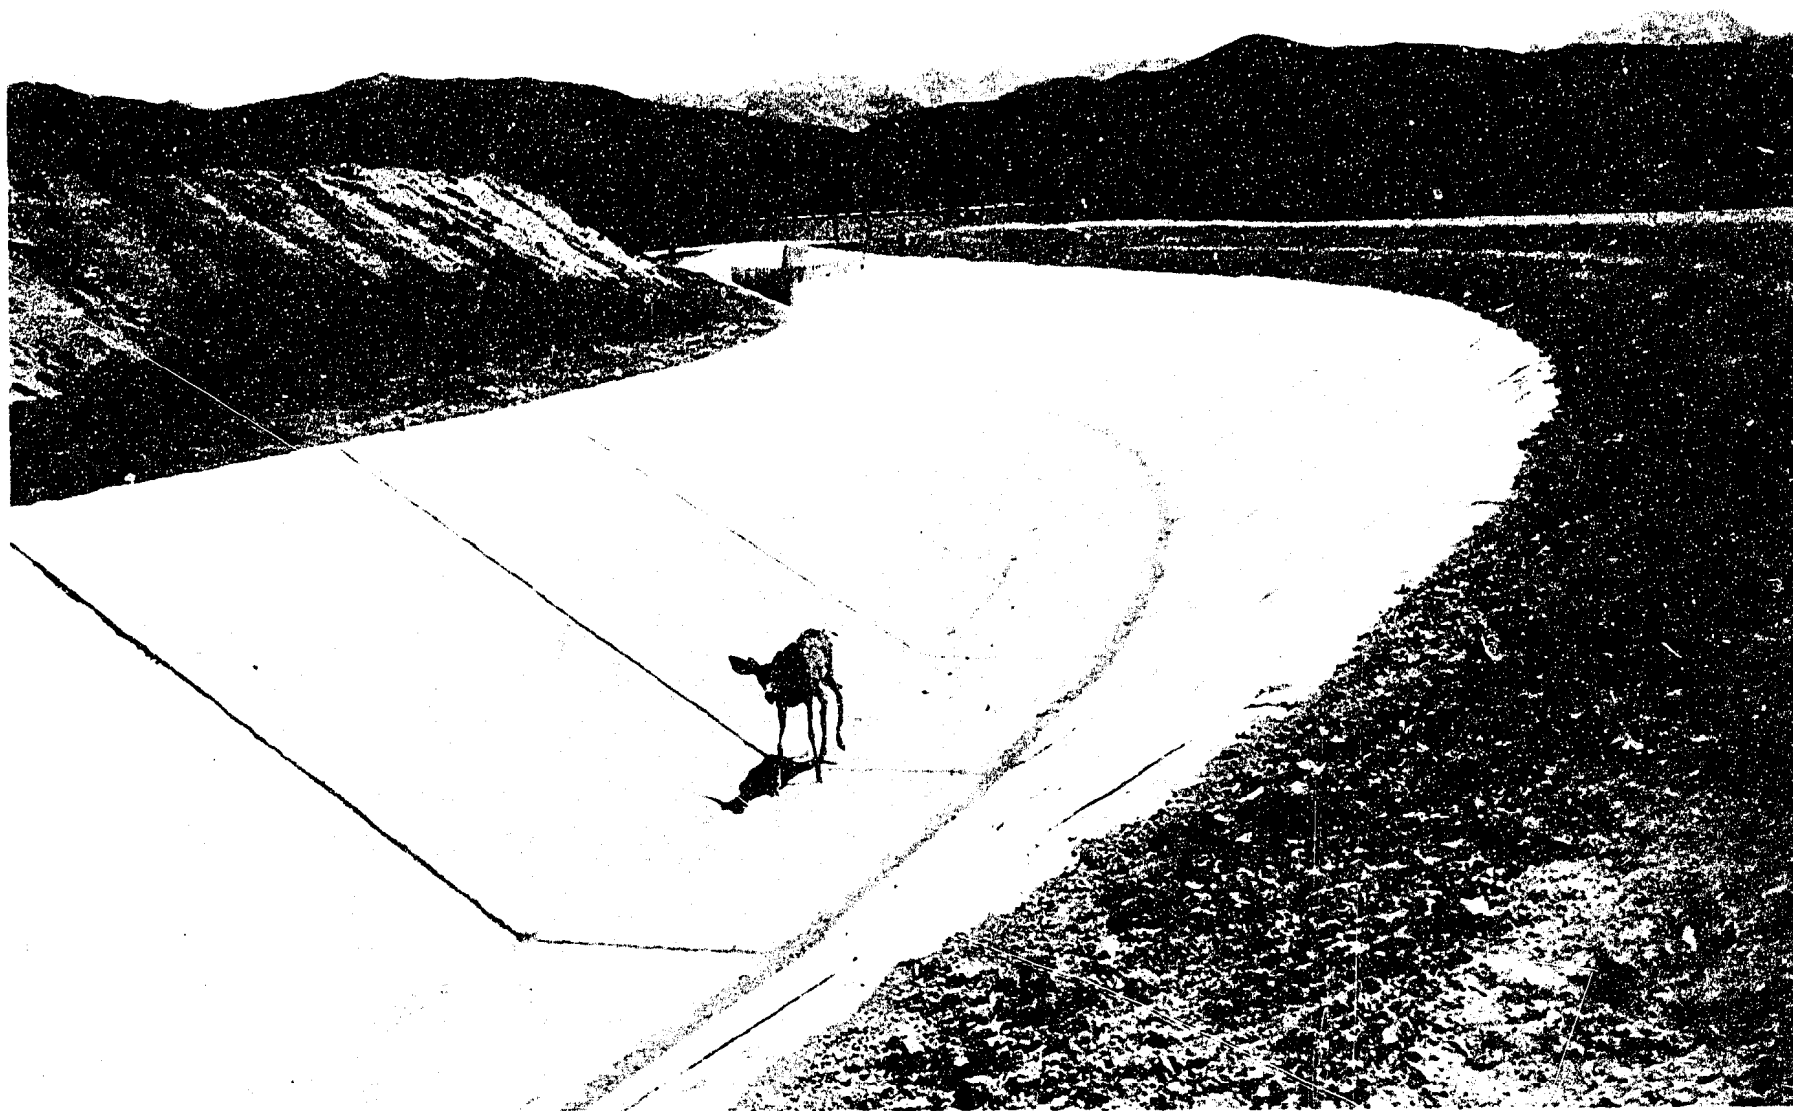
Wild deer trapped in a canal just upstream from the entrance to an inverted siphon. Colorado-Big Thompson Project, Colorado.

Operation of various canal systems indicated there was a need for a device that would provide a measure of safety at the entrance to inverted siphons (see frontispiece). To satisfy this need, model studies were performed to develop a safety device for use on the Gateway Canal, Weber Basin Project, Utah. It was originally intended

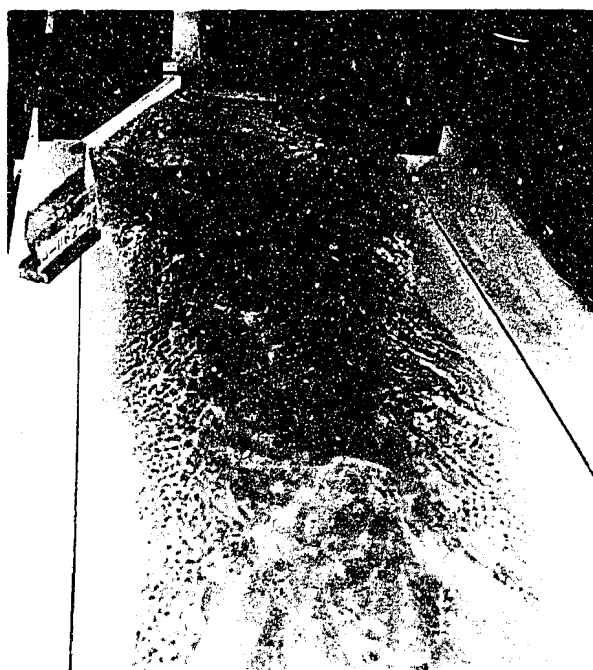
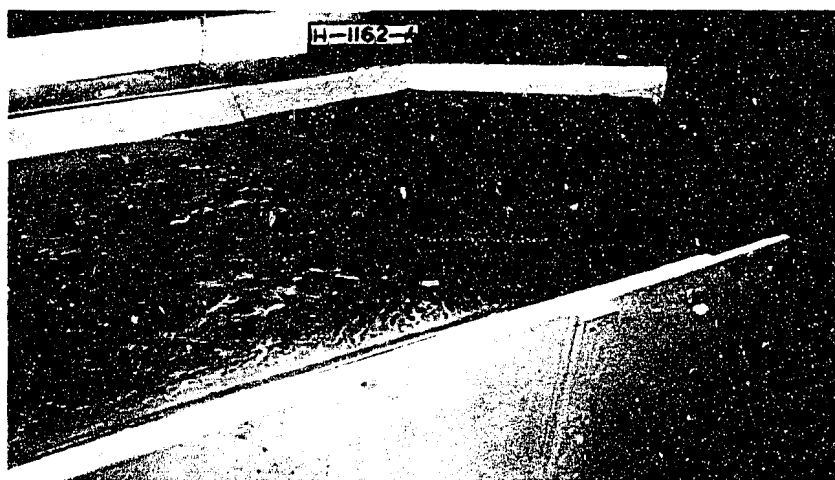
Vortices
form
over
ramp

Undulating canal surface
induced by vortex action

Solid ramp in place

Unprotected siphon entrance
Ramp removed

GATEWAY CANAL MODEL STUDIES
Safety Device for Inverted Siphon
Flow in preliminary design at 700 cfs

The flow appearance with this device was very poor. Two large vortices formed at the upstream edge of the ramp that were of such magnitude that floating or partially submerged objects in the canal were swept into one or the other of the vortices and immediately carried down into the inverted siphon. Figure 3 shows the flow appearance with this safety device. Also shown is the flow appearance at the siphon entrance with the safety device removed. A comparison of these pictures shows that the preliminary safety device produced a flow condition at the siphon entrance more dangerous than was present without a safety device.

Without the safety device the flow up to the siphon entrance was very smooth with only very slight local disturbance directly over the entrance. Floating objects were carried to the headwall of the siphon entrance where they were held; however, since the wall was vertical, there was no chance for escape. Partially or totally submerged objects on the other hand were immediately swept down into the siphon barrel.

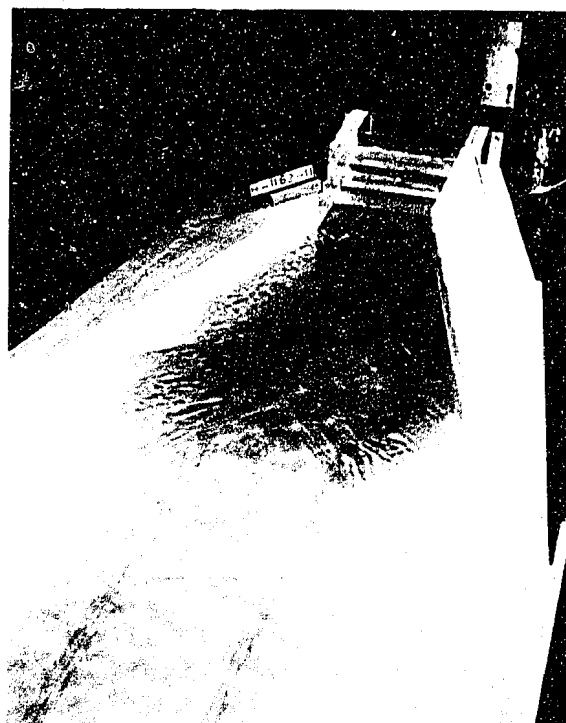
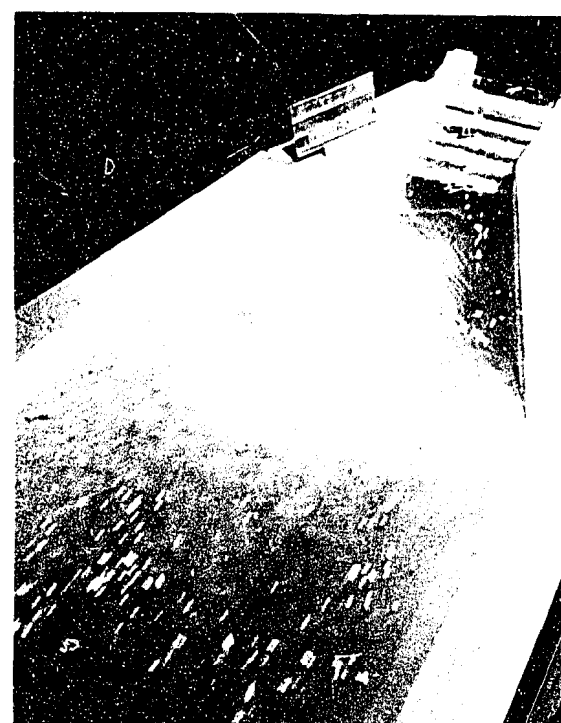
No flow

350 cfs

700 cfs

Note model "deer" carried
to safety on stepped ramp

GATEWAY CANAL MODEL STUDIES
Inverted Siphon Safety Device
Recommended design

The recommended structure was checked at the maximum discharge of 700 cfs and at half discharge of 350 cfs. The flow appearance was very good at both discharges, Figure 10, indicating that the device would operate satisfactorily for the most prevalent discharge range. The performance of the structure was also checked by means of floating confetti and by dye streams injected into the flow at varying depths. The confetti showed that the surface flow lines were very smooth as the flow approached the inverted siphon and the safety device caused no objectionable vortices or other eddy currents. The flow lines for the 700 cfs discharge are shown by the white confetti traces in the picture on the right side of Figure 10. The subsurface currents, checked at the two discharges by means of dye streams injected into the flow at varying depths, also showed that the flow approaching the inverted siphon was very smooth with no objectionable eddy currents.
